**PRELIMINARY ASSESSMENT/
VISUAL SITE INSPECTION**

**PPG INDUSTRIES, INC., WORKS NO. 26
CRESTLINE, OHIO
OHD 004 199 030**

FINAL REPORT

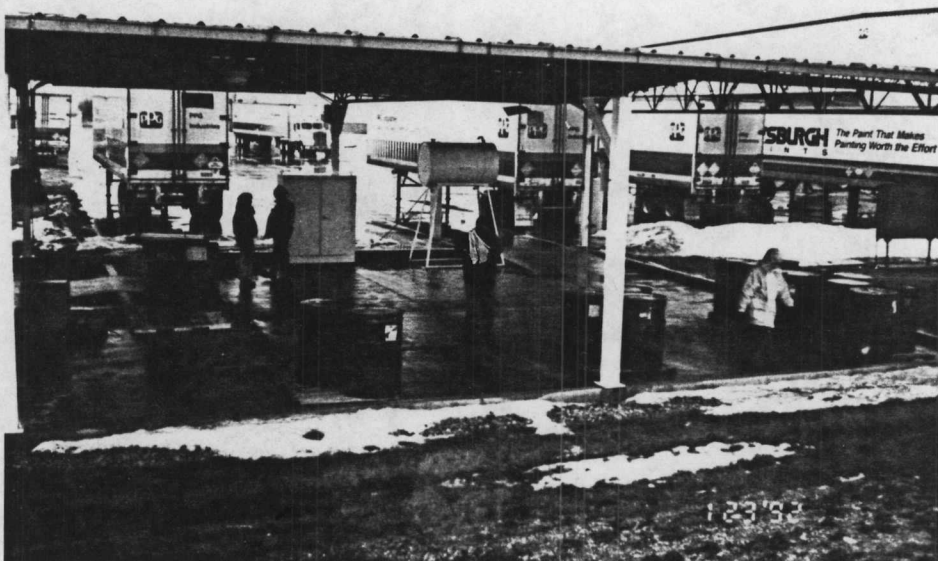
Photograph No. 2
 Orientation: Northeast
 Description: Hazardous Waste Accumulation Area (Southern Section)

Location: SWMU 1
 Date: 01/23/92

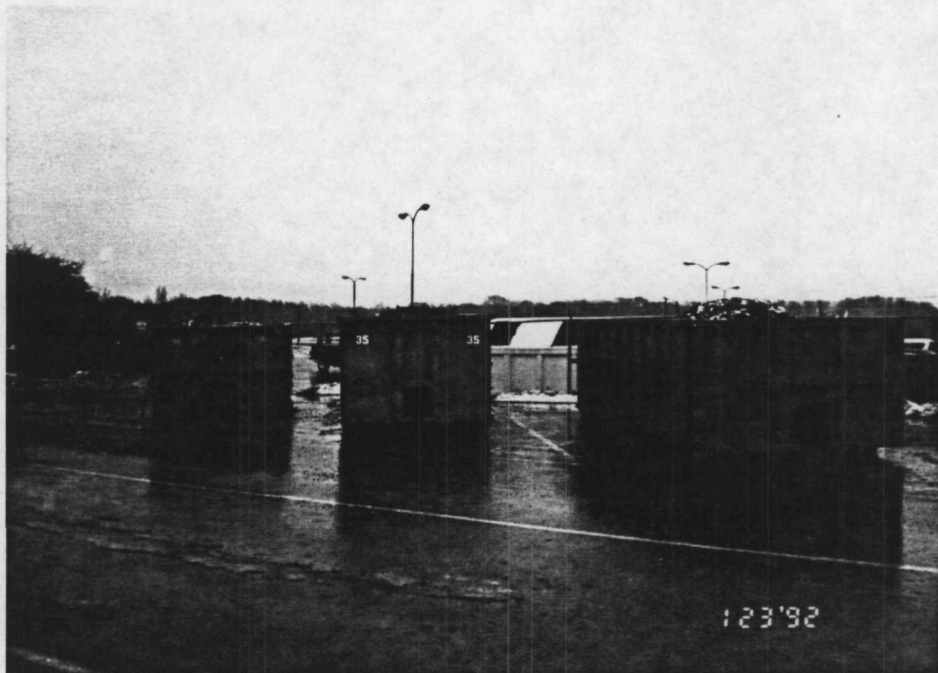
Photograph No. 3
 Orientation: Northeast
 Description: Hoppers Storing Cullet

The hopper used is similar to those shown in Photo No. 3. The hoppers have no visible cracks.

Location: NA
 Date: 01/23/92

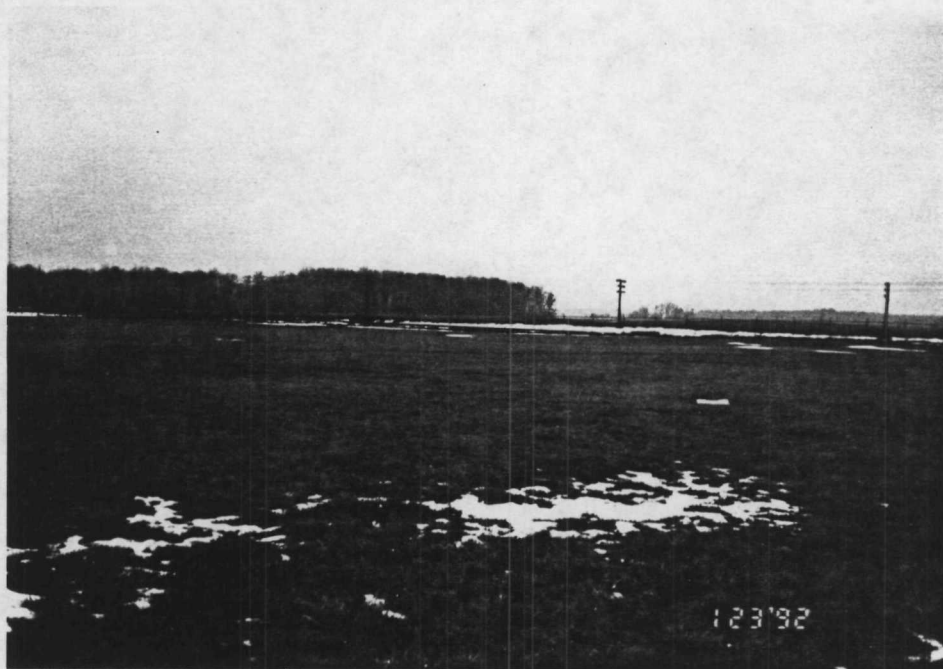
Photograph No. 4
 Orientation: Northwest
 Description: Former Pond Area Filled With Clean Soil

Location: NA
 Date: 01/23/92
